NRL Report 5920

Fracture Analysis Diagram Procedures for the Fracture-Safe Engineering Design of Steel Structures

W. S. PELLINI AND P. P. PUZAK
Metallurgy Division

March 15, 1963

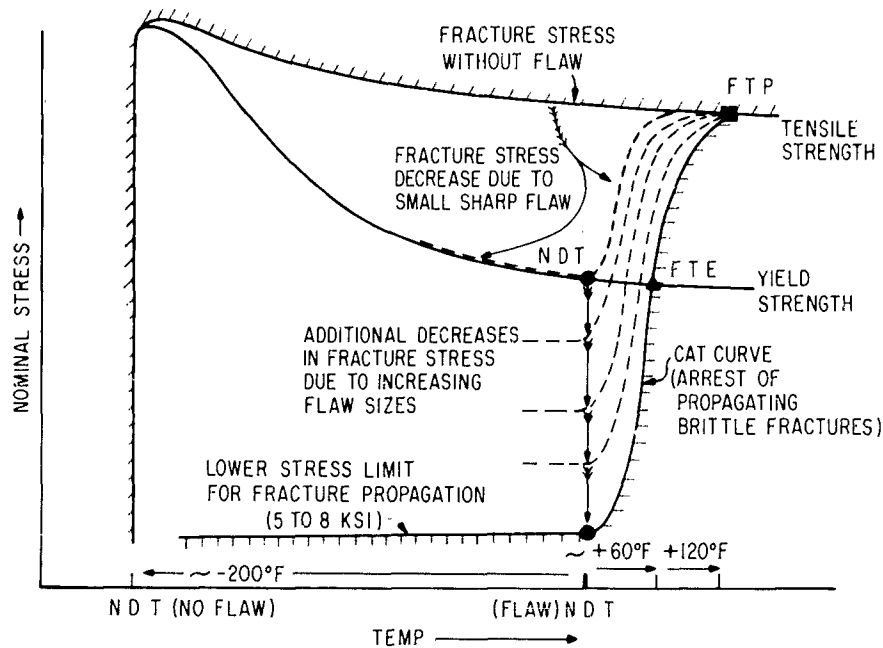
Fig. 1 — Transition temperature features of steels

The significance of the NDT temperature may be brought out by discussion of the general effects of temperature on the fracture stress transition of steels (Fig. 1). A flaw-free steel is illustrated to develop a gradually increasing tensile strength (T.S.) and yield strength (Y.S.) with decreasing temperature; the increase in yield strength is greater than that of the tensile strength, resulting in coincidence at some very low temperature. At the temperature of coincidence, tensile ductility as measured by elongation or reduction of area (plastic flow) is decreased to essentially zero or nil value. This temperature may be considered as the NDT temperature in the *absence* of a flaw. If a small, sharp flaw is placed in the test specimen, such as a plate, a decreased level of fracture stress is obtained in the transition range as indicated by the dashed curve labeled "fracture stress decrease due to small, sharp flaw." The highest temperature at which the decreasing fracture stress for fracture initiation due to the small flaw becomes contiguous with the yield strength curve of the steel is defined as the nil ductility transition (NDT) temperature. Below the NDT temperature the fracture stress curve for the small flaw follows the course of the yield strength curve, as indicated by the continuation of the dashed curve to lower temperatures. The arrows pointing down from the NDT point indicate that increases in the flaw size result in progressive lowering of the fracture stress curve to lower levels of nominal stress. As an approximation, the fracture stress is inversely proportional to the square root of the flaw size. The resulting family of fracture stress curves are characterized by a common temperature effect, involving a marked increase in the stress required for fracture as the temperature is increased above the NDT temperature.

A curve noted as CAT (crack arrest temperature) is drawn to represent the fracture *arrest* relationship between stress and temperature. The CAT curve represents the temperature of arrest of a propagating brittle fracture for various levels of applied nominal

stress. The crack arrest temperature for a stress level equal to the yield strength has been defined by the authors in previous reports as the "fracture transition elastic" (FTE) temperature and marks the highest temperature of fracture propagation for purely elastic loads. Similarly, the "fracture transition plastic" (FTP) temperature has been defined as the temperature above which fractures are entirely shear, *i.e.*, show no center regions of cleavage fracture, and the stress required for fracture approximates the tensile strength of the steel. The lower shelf in the range of 5 to 8 ksi, labeled as the "lower stress limit for fracture propagation" represents the stress level, below which fracture propagation is not possible because the minimum, small amount of elastic strain energy release required for continued propagation of brittle fractures is not attained.

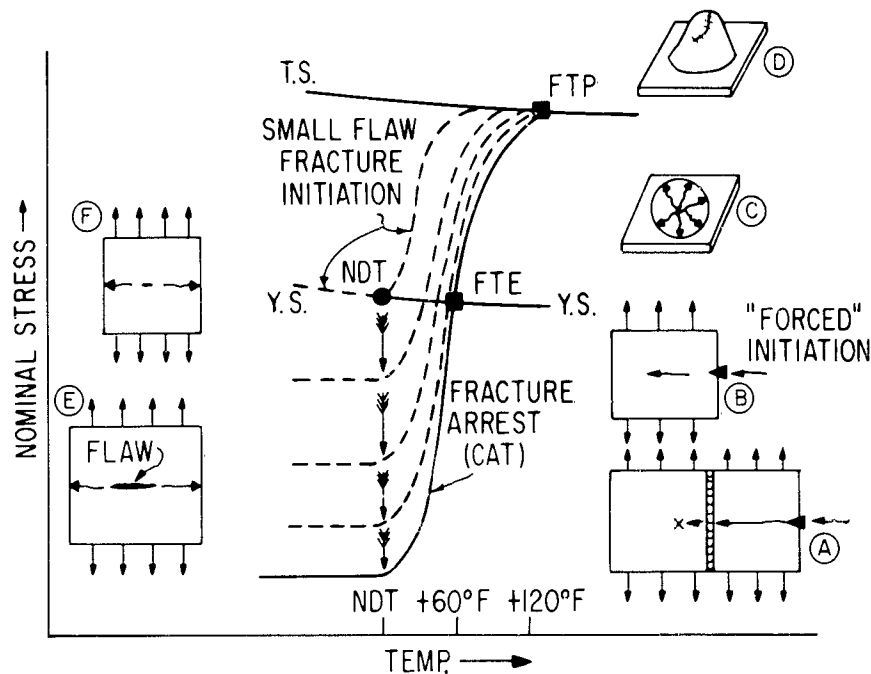
Fig. 2 — Features of large-scale fracture initiation and fracture arrest tests

The various types of tests which have provided data required to chart this diagram are illustrated in Fig. 2. Crack arrest tests may be conducted with a composite plate comprising a brittle plate welded to a "test" plate, sketch (A). After the assembly is brought to a specific temperature and stress level, "forced" initiation of a fracture in the brittle plate by wedge impact is used to develop a rapidly running brittle fracture. The fracture continues through the "test" steel or stops, depending on whether the temperature is below or above the CAT for the steel at the specific stress level of the test. A series of tests are conducted to establish the boundary of the "run" and "stop" temperatures. Variations of this test include wedge impact starting of a fracture in

the test plate itself, sketch (B), or in a prolongation of the test plate, which is cooled to low temperatures. Data on crack arrest properties at stresses and temperatures above the FTE point have been obtained primarily by the use of crack-starter explosion tests, sketches (C) and (D), to be explained. FTP performance in this test is indicated by the development of a deep hemispherical bulge with fractures restricted to short, shear tears, sketch (D).

Large-scale, fracture initiation tests have been conducted by introducing flaws (fatigue cracks, brittle weld cracks, etc.) of various dimensions in a test plate and loading to establish the fracture stress, sketches (E) and (F). Figures 1 and 2 illustrate that the family of dashed curves representing the fracture initiation stress for various flaw sizes are bounded or "cut off" by the CAT curve. This curve begins to rise sharply at the NDT temperature with a slope such that the CAT for yield stress loading (FTE) is reached at $NDT + 60^{\circ}F$ and FTP properties are reached at $NDT + 120^{\circ}F$.

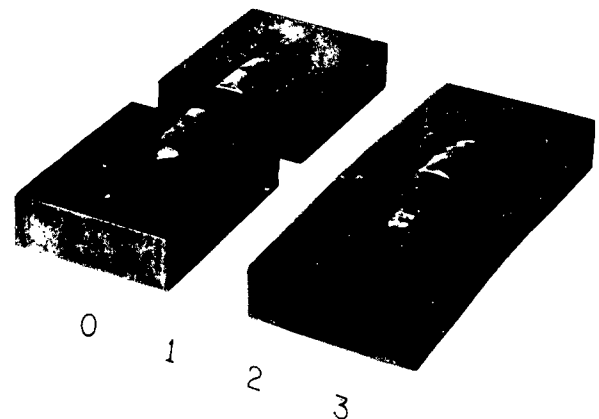
Fig. 3 — Drop-weight test specimen ($2 \times 5 \times 5/8$ in.) before test (right) and after test at, or below, the NDT temperature (left), illustrating the function of the brittle weld as a "crack starter" flaw

The importance of the NDT temperature as a *reference point for the generalized diagram* resides in the fact that it may be determined easily by the use of the drop-weight test. Figure 3 illustrates a drop-weight test specimen before and after test below the NDT temperature. The drop-weight test features the use of a brittle weld bead which cracks on "bend" loading to the yield point of the test plate surface. The resulting brittle crack represents the starting flaw or notch. The size of this

flaw (approximately $1/2 \times 1/4$ in.) characterizes the test as a "small flaw" initiation test. A stop placed beneath the center point of the specimen span restricts the test loading to stress conditions involving incipient yielding. The specimen shown represents the smallest size of a series of sizes that may be used (1,2). Figure 4 illustrates the simplicity of the test equipment; details of the anvil are evident from the enlargement. The samples are brought to a desired temperature, placed on the test anvil, and the weight released to provide for loading to the point controlled by the stop. As illustrated by Fig. 5, a series of specimens are tested at 10°F intervals—the highest temperature of "break" indicates the NDT of the steel. The sharp transition from "break" to "no break" at the NDT temperature results from the marked increase in the levels of deformation required for fracture initiation at temperatures above the NDT. This feature is illustrated by the steep slope of the fracture stress curve which corresponds to "small flaw" condition of the drop-weight test at temperatures above the NDT point, Figs. 1 and 2.

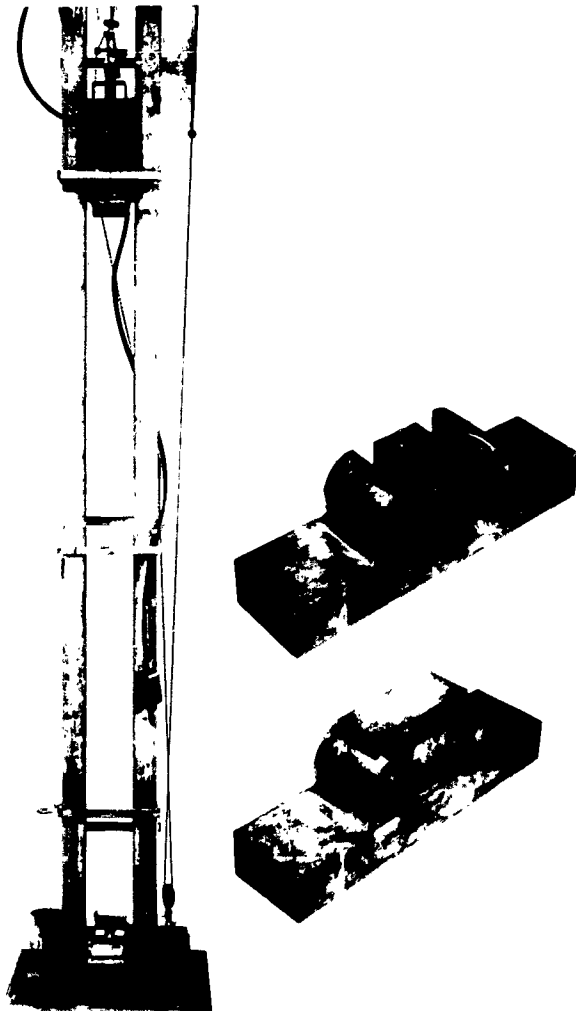
Fig. 4 — Drop-weight test equipment (left); details of anvil for 2x5x5/8 in. specimens (right)

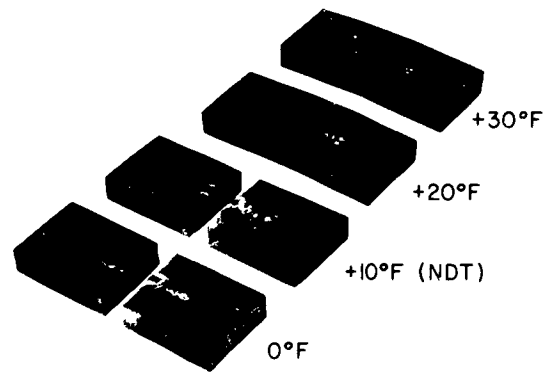
Fig. 5 — Typical drop-weight test series, illustrating an NDT at 10°F

Figure 6 documents the high resistance to fracture initiation exhibited by the same steel shown in Fig. 5 for tests at temperatures above the NDT, with a special demonstration series featuring an open span (no stop). Unlike most laboratory fracture tests which tend to develop data scatter, the drop-weight test is highly reproducible. Another feature of the test is that it is insensitive to orientation with respect to rolling or

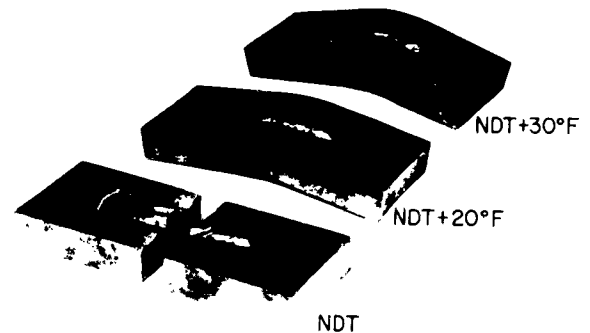
Fig. 6 — Open anvil test series illustrating bend deformation (ductility) developed at temperatures above the NDT temperature as compared to the “flat break” at and below the NDT temperature

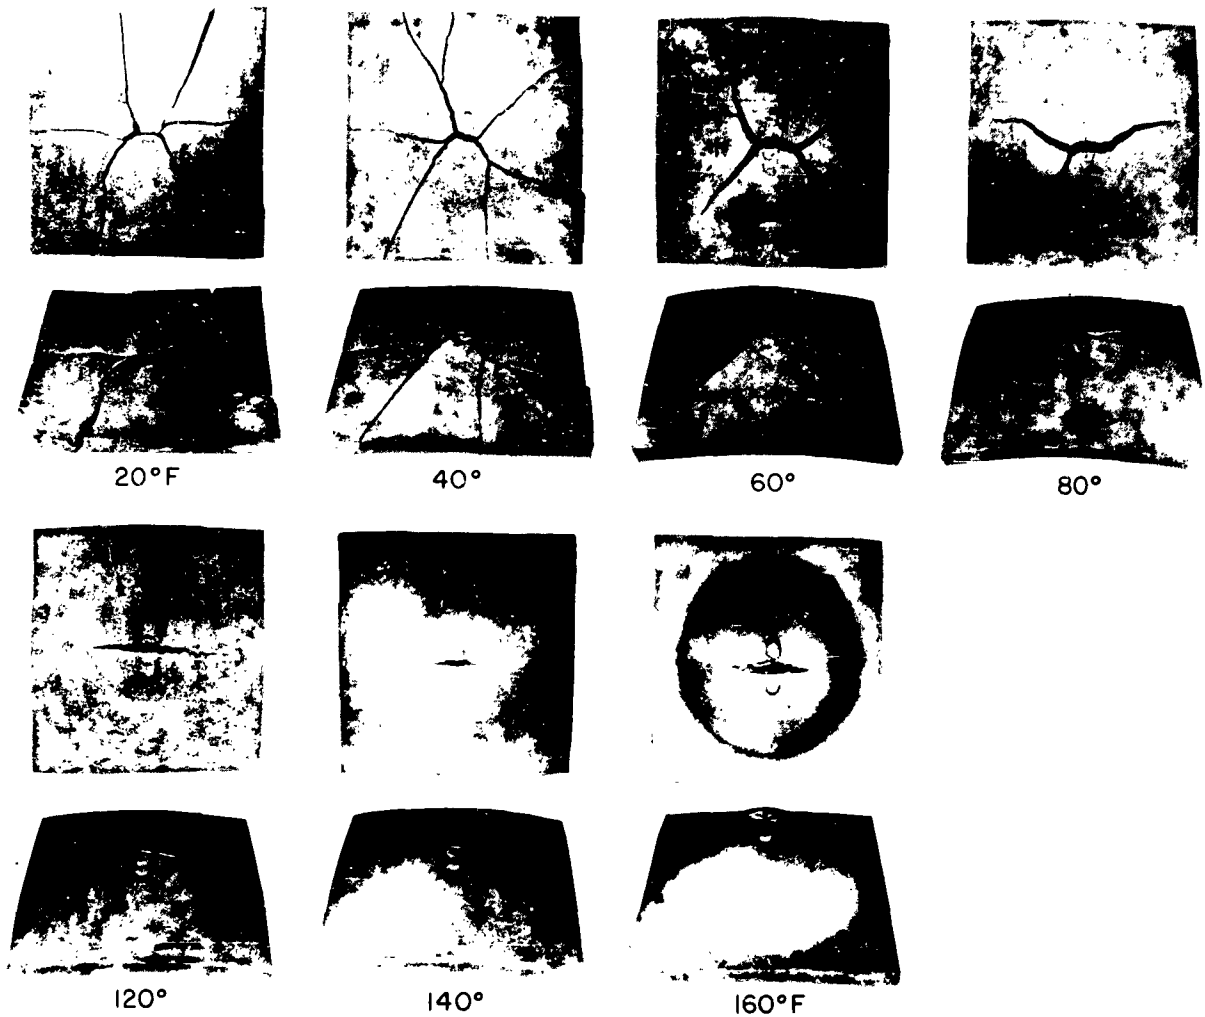
Fig. 7 — Explosion crack-starter test series in 20°F steps illustrating the dramatic increase in fracture toughness of steels above the NDT temperature (for the steel shown, NDT = 20°F, FTE = 70°F, and FTP = 140°F)

Figure 7 presents a panoramic view of the dramatic temperature effect in 20°F steps, for a World War II ship plate steel test series. At and below the NDT temperature, 20°F for this steel, the test plates break “flat.” Above the NDT temperature the plates *bulge* before fracture, indicating difficult (plastic strain required) starting of the fracture. In conformance with the plastic strain-temperature relationships of the small flaw fracture initiation curve at temperatures above the NDT temperature, the level of pre-fracture bulging (plastic stress levels) increases continuously with increasing temperature in the NDT to FTP range. The fractures, once started, run through the “hold down” regions of the bulge (elastically loaded die supported regions) at all temperatures below the FTE. At temperatures above the FTE, the fractures are entirely contained in the

plastic loaded regions of the bulge (short fractures). Above the FTP temperature only short, ductile tears are developed, even with the intentional forcing of deformation to a complete hemisphere, as shown by the 160°F test plate of the series. The FTP temperature is approximately 120°F above the NDT temperature. These results have been confirmed for a wide variety of steels and for plates up to 3 in. in thickness.

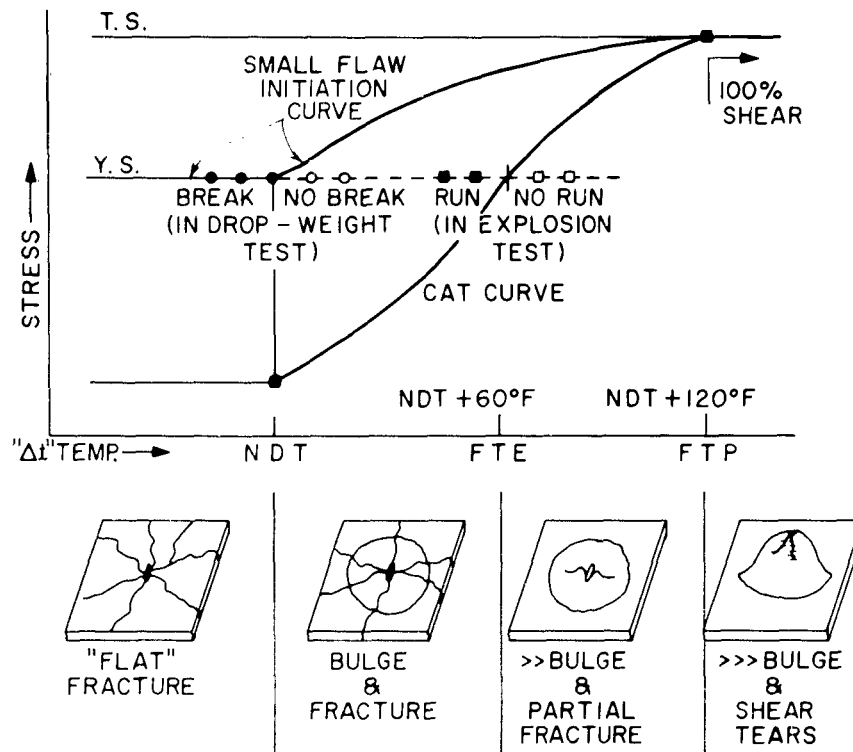
Fig. 8 — Drop-weight and explosion crack-starter test series related to the generalized fracture diagram

By reference to Fig. 8, we may now relate drop-weight and explosion test performance to the fracture analysis diagram, as follows:

1. Nil ductility (fracture of drop-weight specimens and flat break in explosion tests) occurs at and below the NDT temperatures.

3. Above the FTE temperature, fractures do not run through the elastic load or "hold down" regions, thus indicating the CAT for yield stress loading has been exceeded.

4. Propagation of partially brittle fractures through the plastically deformed center regions of bulge are developed in the range between the FTE and FTP temperatures.

5. Short, shear tears are developed above the FTP temperature. The use of unusually large amounts of explosives results in the development of a deep bulge.

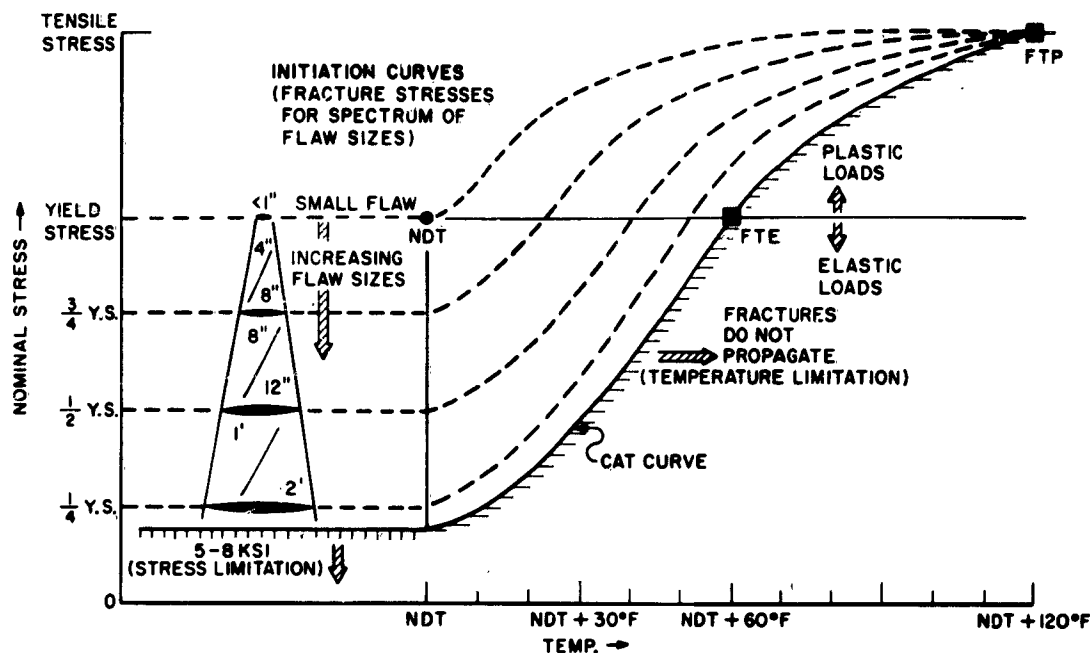
Fig. 9 - Generalized fracture analysis diagram, as referenced by the NDT temperature

The approximate range of flaw sizes required for fracture initiation at various levels of nominal stress are illustrated by the generalized fracture analysis diagram of Fig. 9. The flaw size data have been derived from a wide variety of small flaw tests, from limited studies of tensile tests with large flaws introduced into 1 in. and 3/4 in. thick plates, and from theoretical fracture mechanics concepts developed by G. R. Irwin (3). Validation is provided by a large amount of failure and structural test data, to be presented. The generalized diagram presents a family of fracture initiation curves relating to a range

of flaw sizes. These range from flaws of less than 1 in. (top dashed curve) to flaws in the order of 1 to 2 ft (bottom dashed curve). It should be noted that all initiation curves have been drawn to show a rapidly increasing requirement for higher stresses with increasing temperature above the NDT temperature. The actual slope and shape of the "rising" portions of the initiation curves represent estimates based on the general slope of the crack arrest curve.

The diagram predicts that for a given level of stress, larger flaw sizes will be required for fracture initiation above the NDT temperature. For example, at stresses in the order of 3/4 Y.S., a flaw in the order of 8 to 10 in. may be sufficient to initiate fracture below the NDT temperature; however, at NDT + 30°F, a flaw of 1-1/2 to 2 times this size may be required for initiation. To the right of the CAT, there is "no flaw" that is of sufficient size to initiate fracture because propagation of brittle fractures is not possible. It should be noted that the nominal stress plotted in this diagram is the stress acting on the volume of material within which the flaw resides. Thus, for a flaw residing in the shell region of a pressure vessel, the nominal stress is the shell stress vector component; for a flaw residing at a nozzle the nominal stress is the higher level of stress acting at that particular position in the nozzle.

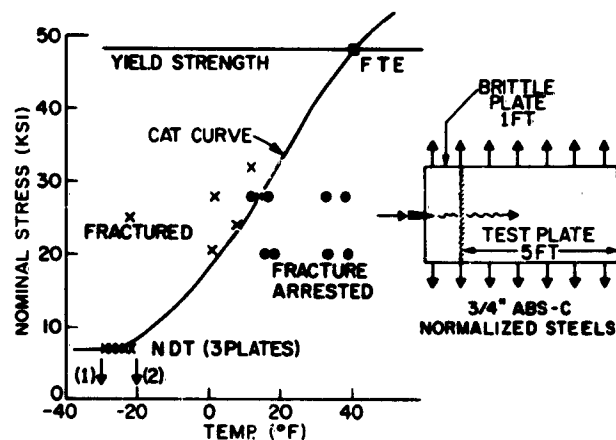
Fig. 10 - Correlation of CAT data obtained by Mosborg (4) with NDT temperatures of the test steels. The data relate to three separate plates from one heat.

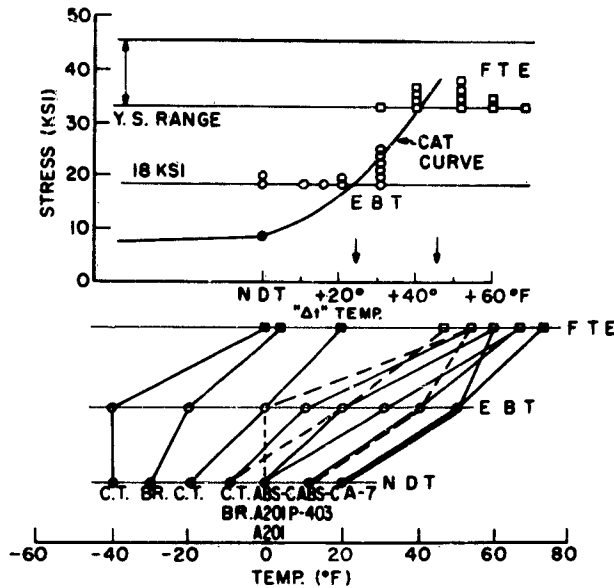
Fig. 11 — The lower graph illustrates the temperatures determined for the NDT, EBT, and FTE for 12 steels; the data relating to each steel are connected by a reference line. The "Δt" relationships of the EBT and the FTE to the NDT temperature are summarized in the upper graph. The crack arrest curve drawn in the top graph represents the "mean position" CAT curve indicated by the "Δt" data points.

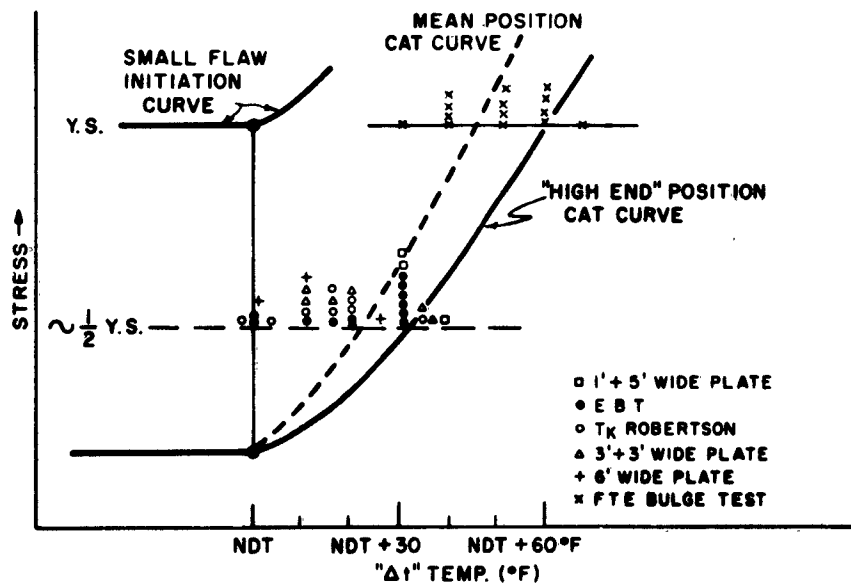
Fig. 12 — Summarization of "Δt" CAT data for 32 steels, representing a wide variety of tests conducted at stress levels of approximately 1/2 the yield strength level of the various steels. A total of 14 steels were also tested by the explosion crack starter test to establish the "Δt" FTE (CAT for Y.S. level). These data represent the bases for the fracture analysis diagram location of the CAT curve referenced to the NDT point.

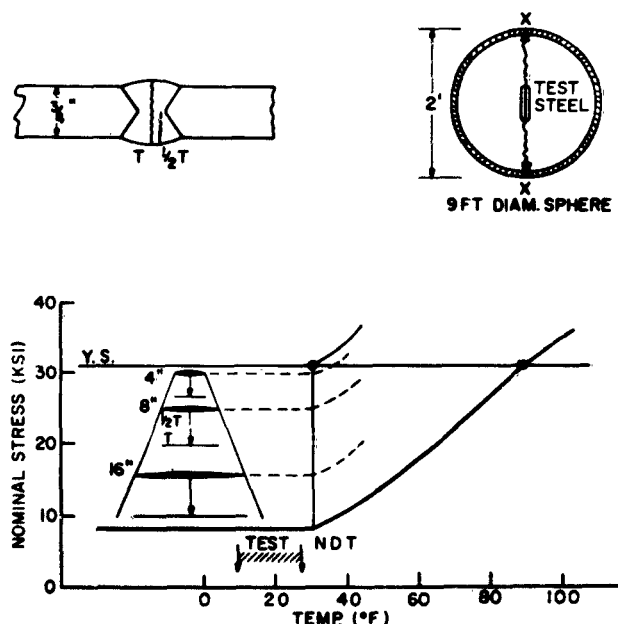
Fig. 13 - Summary of hydrostatic test shell stresses required for the initiation of fracture for flaws of 4, 8, and 16 in. dimensions. All tests were conducted at temperatures ranging from 5° to 20°F below the NDT temperature of the test steel, a 3/4-in.-thick ship plate.

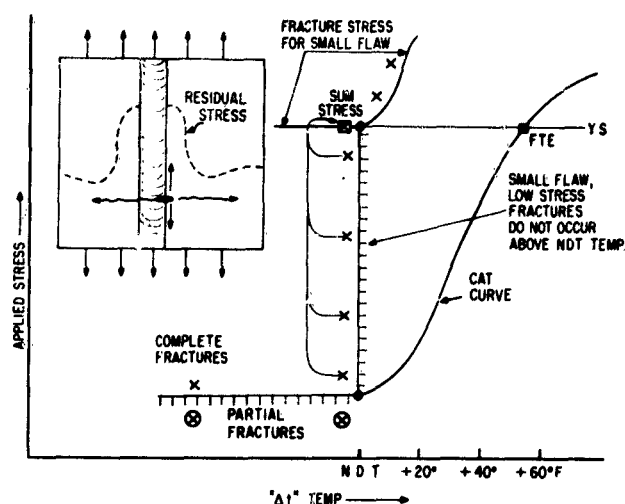
Fig. 14 — Illustrating the fracture analysis diagram prediction that the NDT represents the highest temperature for the initiation of "low-stress" fractures in the presence of high residual stress fields. Complete fractures are predicted for conditions such that the applied stress level exceeds 5 to 8 ksi; short fractures result if the applied stress level is less than this value.

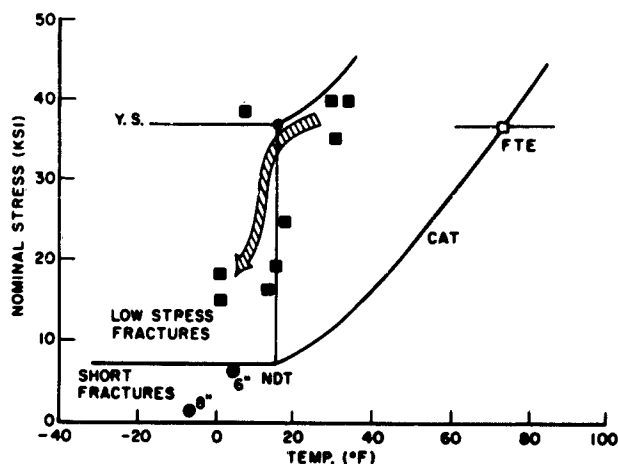
Fig. 15 — Wells (8) data points which define the critical edge temperature for low-stress fracture superimposed on the fracture analysis diagram of the test steel: 1-in. plate, 0.14% C, 1.07% Mn, 0.02% Si.

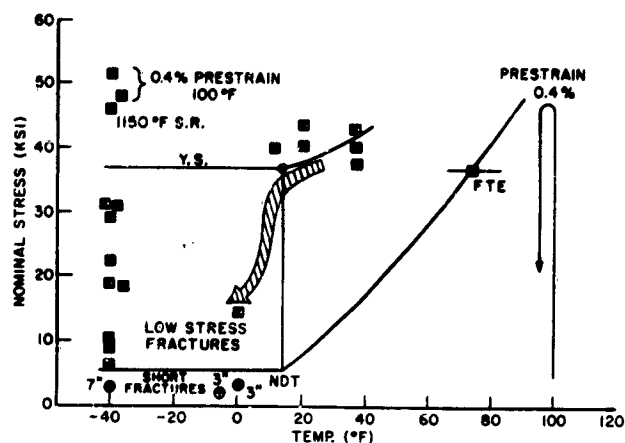
Fig. 16 — Hall, Nordell, and Munse (9) data points which define the critical edge temperature for low-stress fracture superimposed on the fracture analysis diagram for the test steel: 1-in. plate, ASTM A212-B, 0.30% C, 0.76% Mn, 0.26% Si.

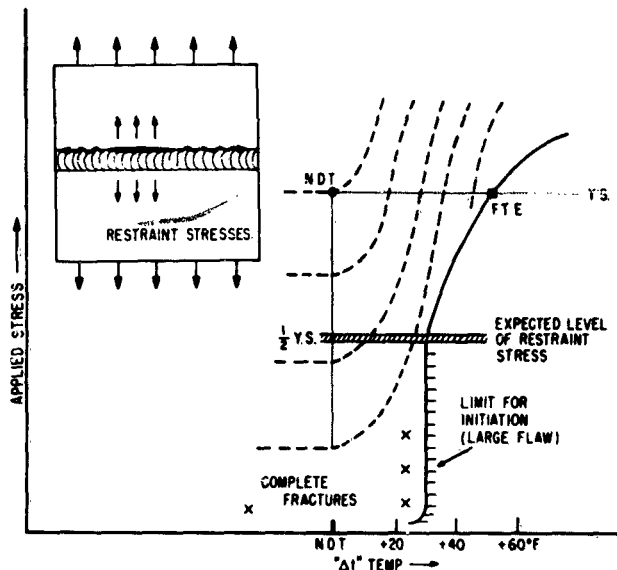
Fig. 17 - Illustrating the fracture analysis diagram prediction that large flaws located in restraint stress fields (of $1/2$ the yield strength) may result in low-stress fracture initiation at temperatures below the CAT ($NDT + 30^\circ F$)

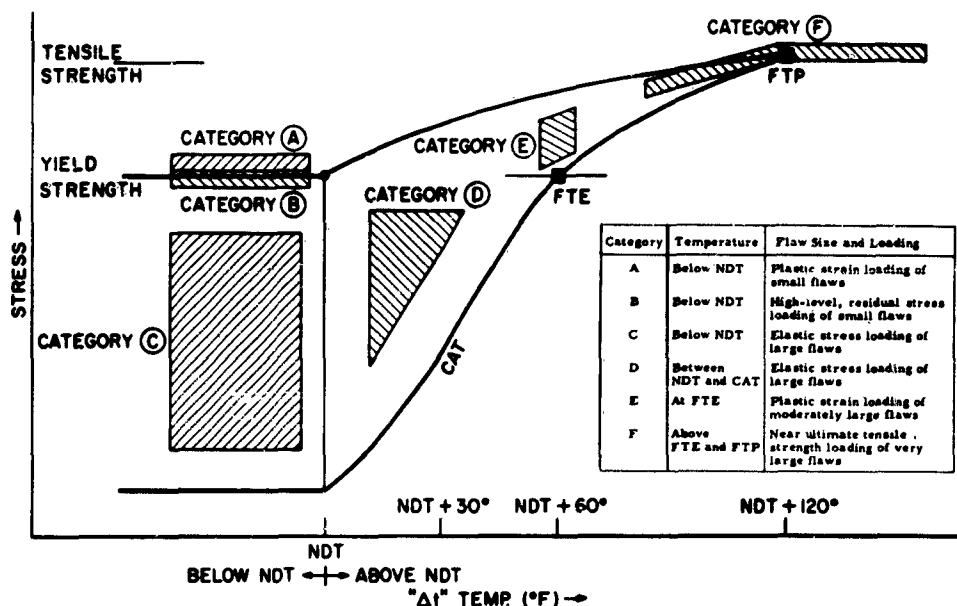
Fig. 18 — Sequence of the discussion of failure-analysis cases is indicated by categories A to F referenced to various zones of the fracture analysis diagram

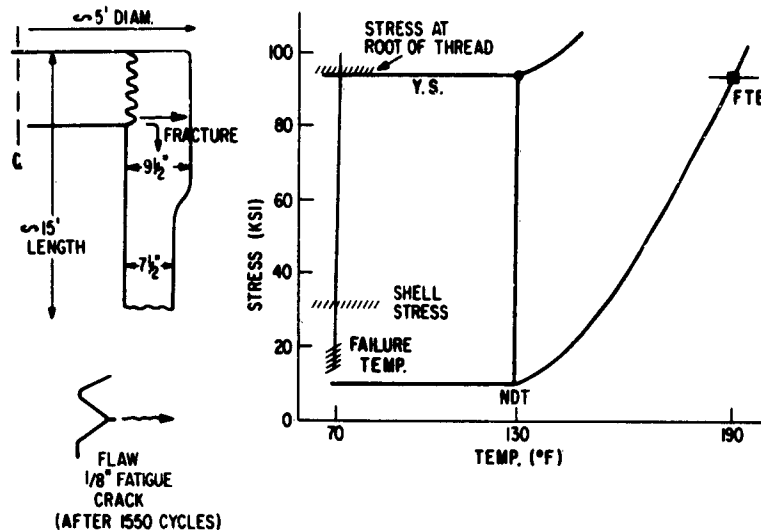
Fig. 21 — (Case A1) Fracture analysis relating to the service failure of the 100-ton, forged, ASTM A293 pressure vessel

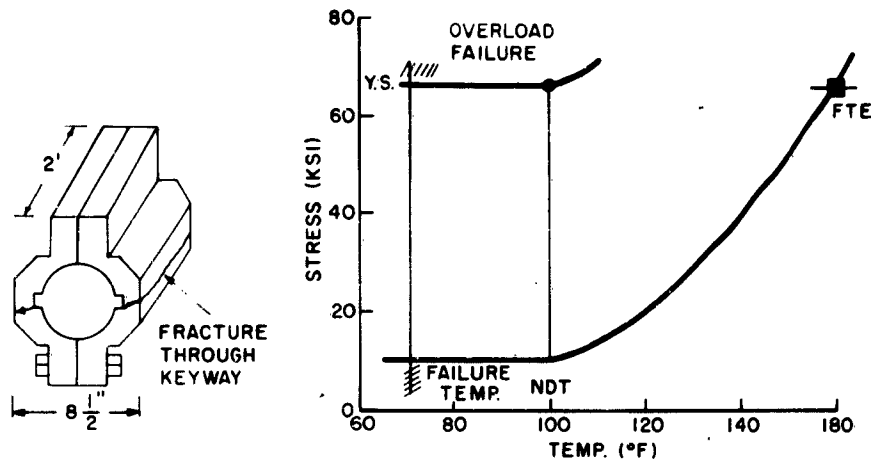
Fig. 23 — (Case A2) Fracture analysis relating to the overload failure of the forged, SAE 1050, anchor windlass-shaft coupling

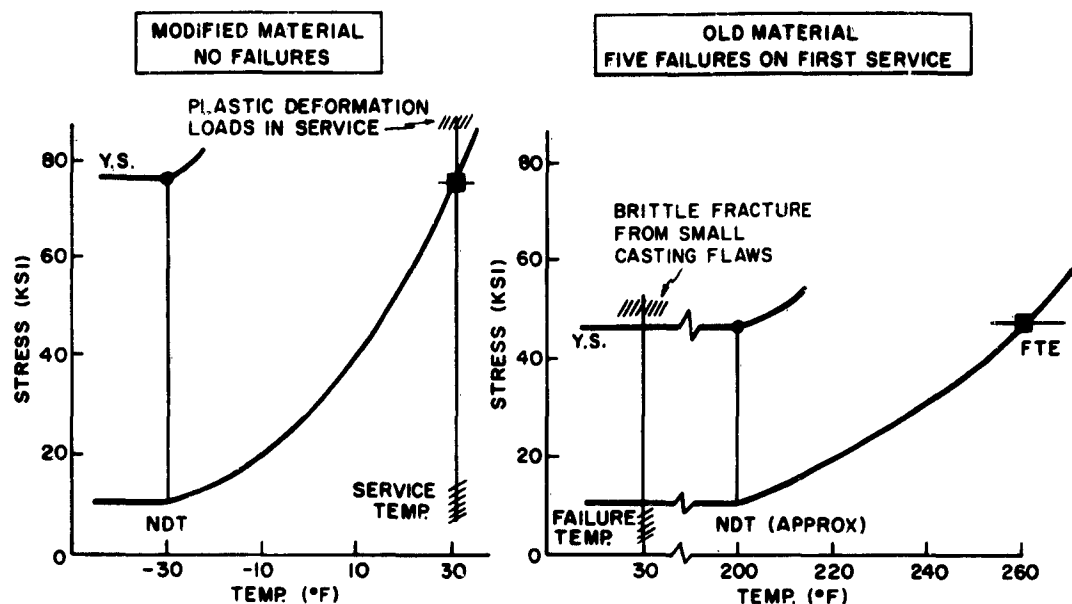
Fig. 25 — (Cases A3 to A7) Fracture analysis relating to the overload failures of cast 12% chromium stainless steel propellers (right); note that the service temperature was below the NDT temperature. Improvement in the steels resulted in shifting the NDT temperature to 60°F below the service temperature. For the improved propeller steels, the fracture analysis diagram (left) predictions for safe performance under overload conditions were justified.

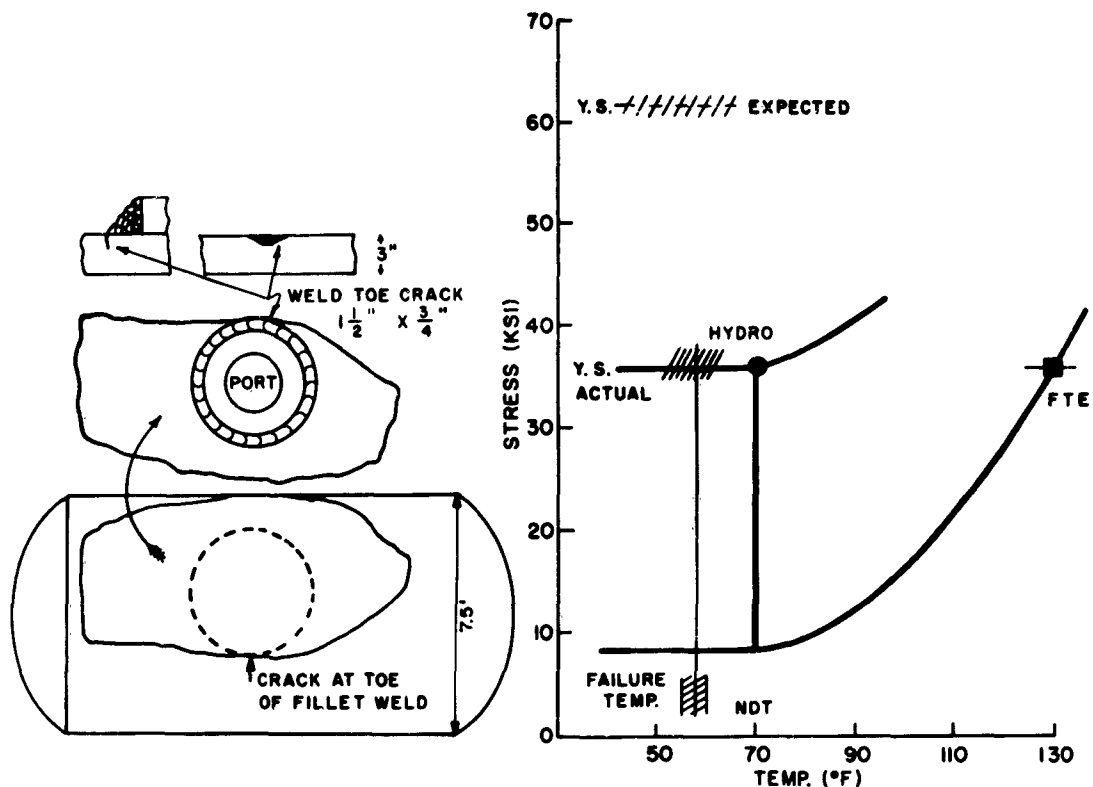
Fig. 27 - (Case A8) Fracture analysis relating to the hydrotest failure of the stress relieved ASTM A302-B pressure vessel. The steel was given an annealing heat treatment by error which resulted in hydrotest shell stresses equal to the yield strength level.

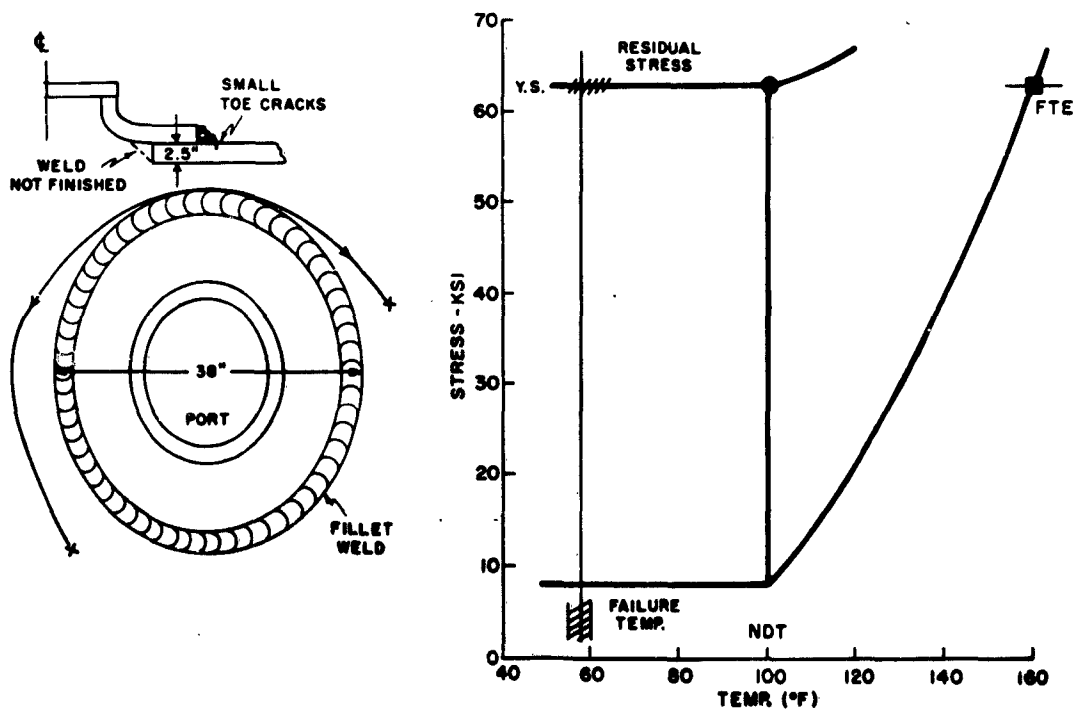
Fig. 28 - (Case B1) Fracture analysis relating to the spontaneous fracture of a partially fabricated ASTM A302-B pressure vessel

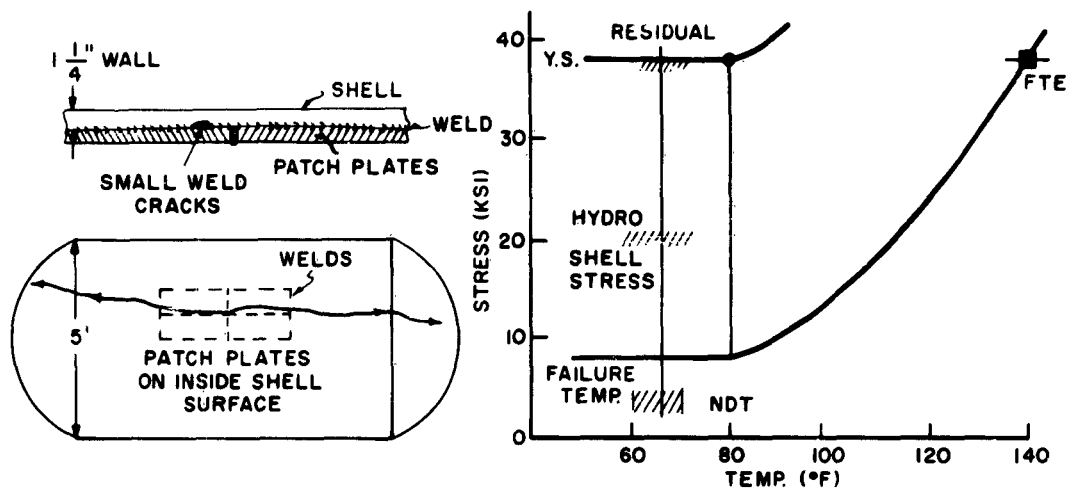
Fig. 30 - (Case B2) Fracture analysis relating to hydrotest failure of the patch-plate-repaired ASTM-A212-B pressure vessel. The vessel was not stress relieved after completion of the weld repairs.

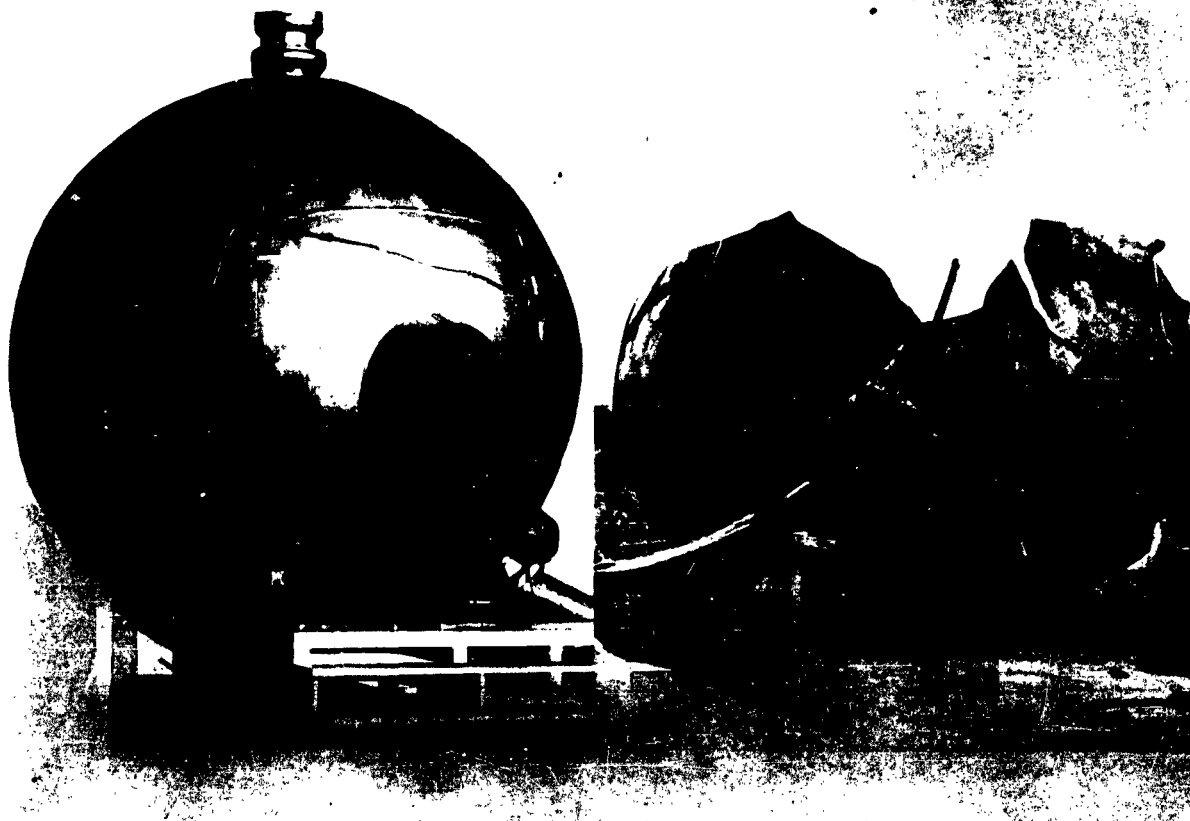
Fig. 31 - (Case B3) Blast chamber prior to fracture (left) and after fracture (right)

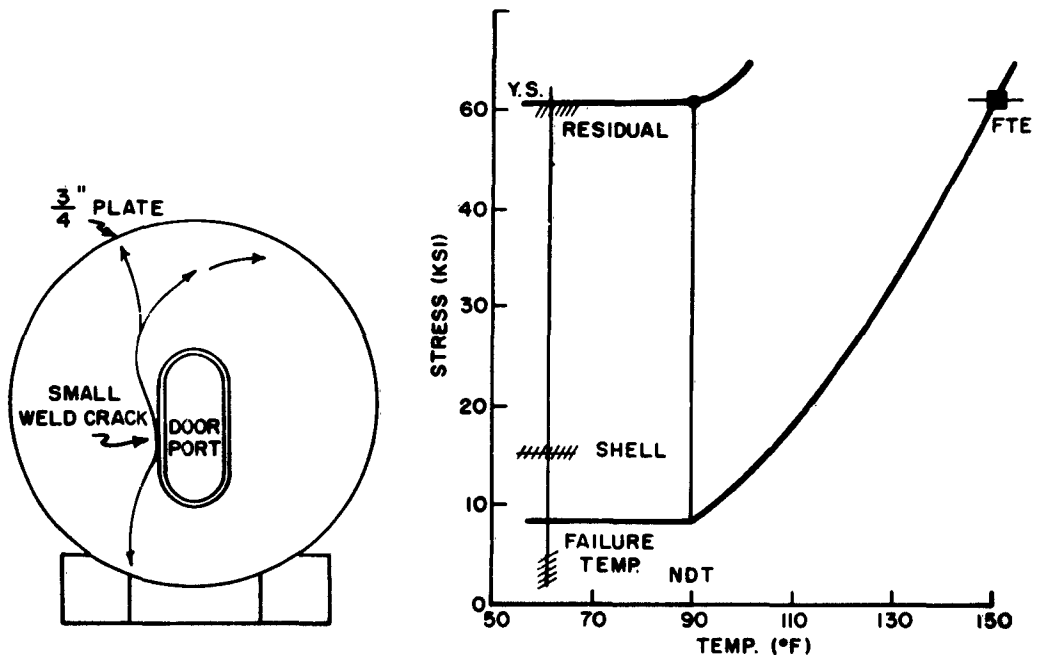
Fig. 32 - (Case B3) Fracture analysis relating to service failure of the ASTM A285-C blast chamber.
The vessel was not stress relieved.

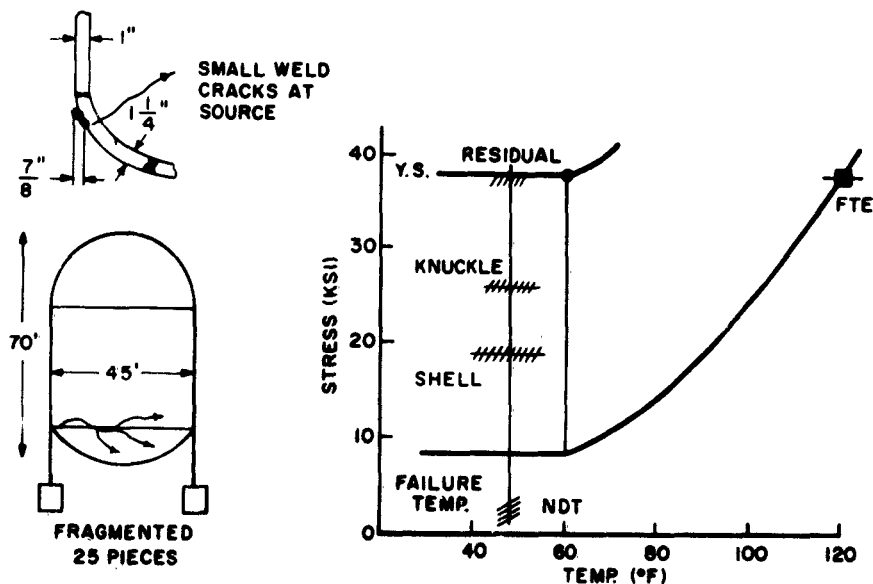
Fig. 33 - (Case B4) Fracture analysis relating to hydrotest failure of a 45-ft-diameter ASTM A285-C storage tank. The vessel was not stress relieved.

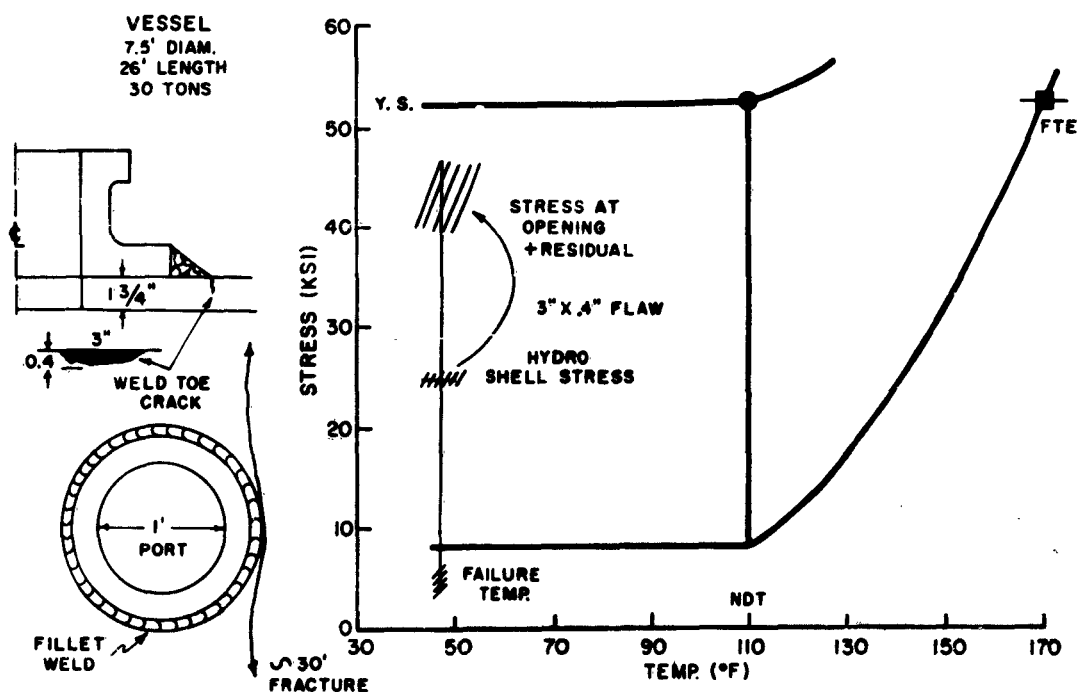
Fig. 36 - (Case B5) Fracture analysis relating to the hydrostatic test failure of the CO converter pressure vessel. The data relate to the ASTM A204 portion, which was the initiation point. The vessel was given an inadequate stress relief at 950°F.

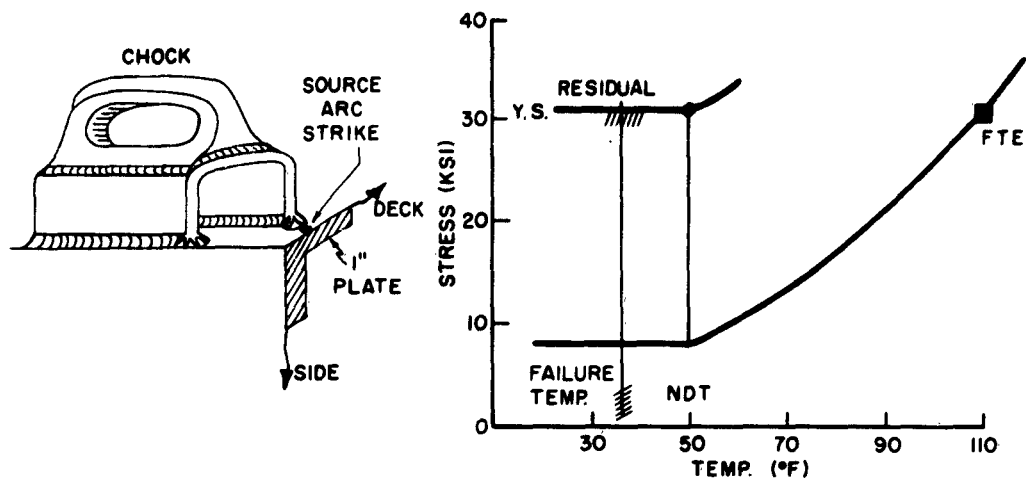
Fig. 38 - (Case B6) Fracture analysis relating to the dockside failure of the T-2 tanker Ponaganset

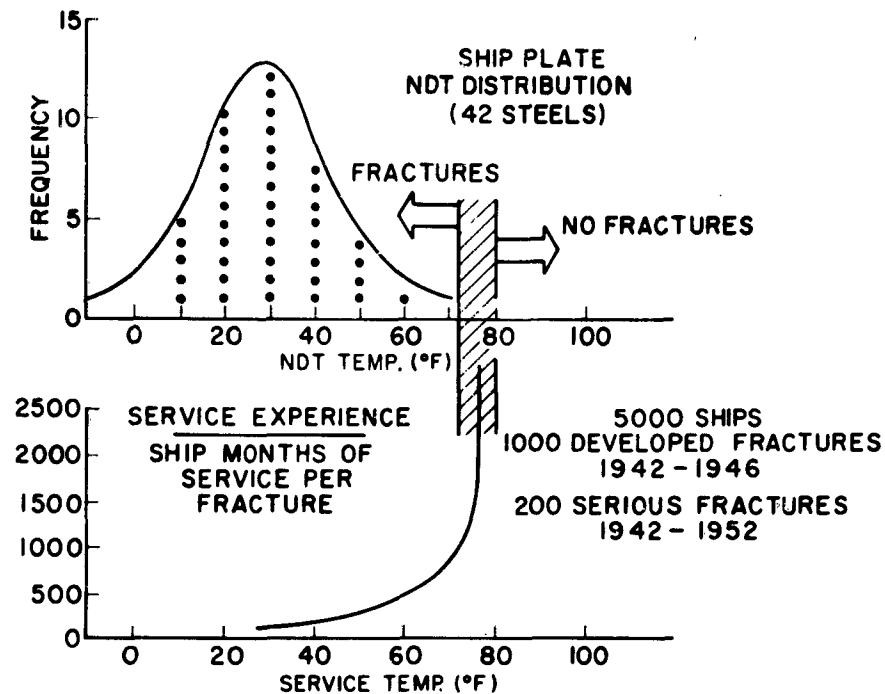
Fig. 40 - Illustrating that no failures of World War II ships occurred at temperatures above the 70°F upper limit of the NDT frequency distribution range of World War II ship steels. A high rate of fracture per month of service occurred at temperatures of 30° to 50°F, for which 20 to 50% of the steels were below their NDT temperatures.

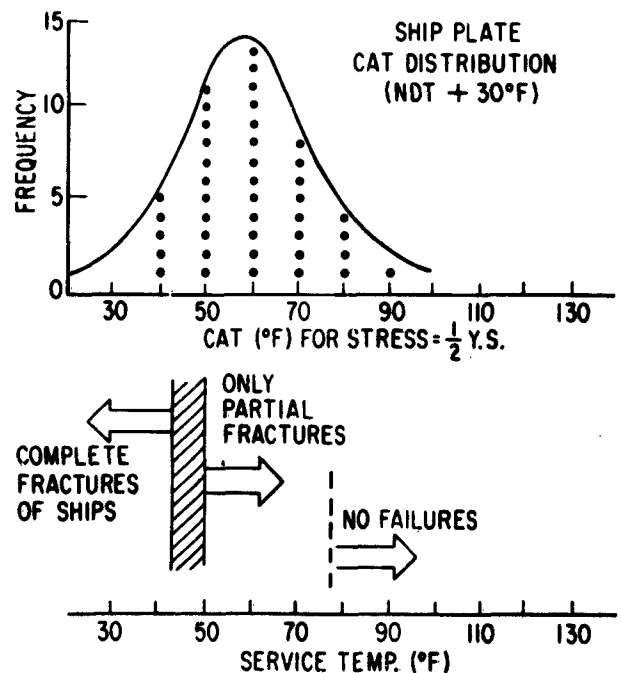
Fig. 41 - Illustrating that complete failure of ships occurred only at temperatures such that essentially all of the ship steels were below their respective CAT

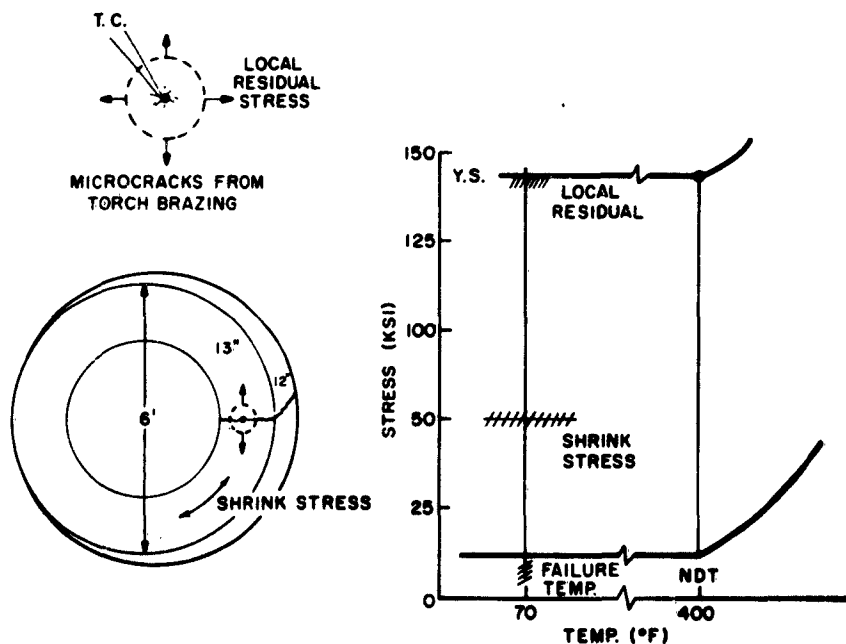
Fig. 44 — (Case B7) Fracture analysis relating to the spontaneous fracture of the ASTM A293 retaining ring forging

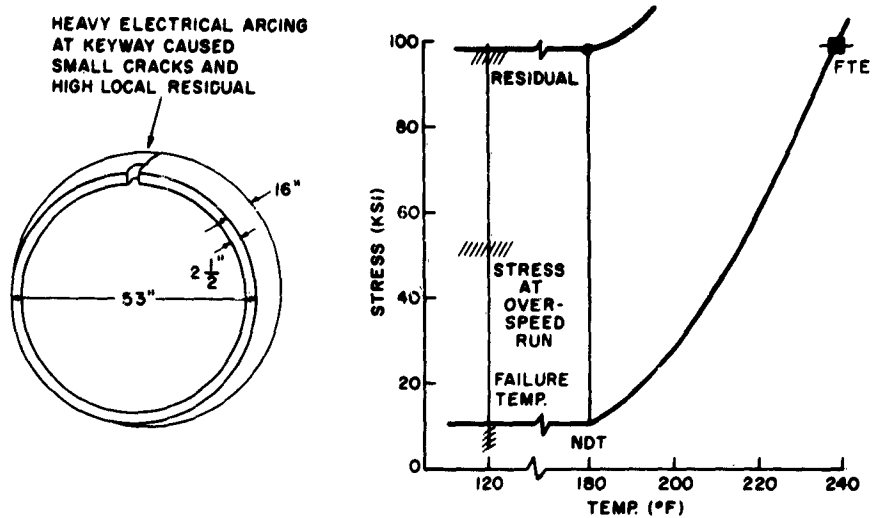
Fig. 46 — (Case B8) Fracture analysis relating to the overspeed run failure of the SAE 3335 retaining ring forging. Data by Greenberg (12).

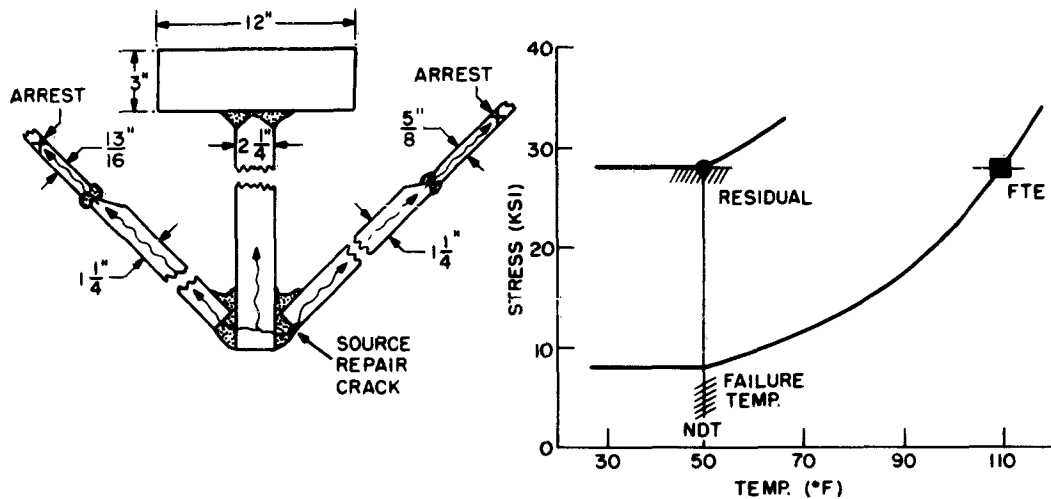
Fig. 48 — (Case B9) Fracture analysis relating to the hydrotest failure of the power dam outlet pipe manifold
